# BAUSCHADENANALYSE PS-KW

SCHADENSAUSMASS UND URSACHEN  
ERMITTLUNG DER WERTMINDERUNG  
PROJEKTUMFELD UND BAUVERTRAGLICHER HINTERGRUND

# ERDBEBENVERHALTEN VON DÄMMEN

**NON EXISTING PROJECT, INSPIRED BY A REAL CASE STUDY**

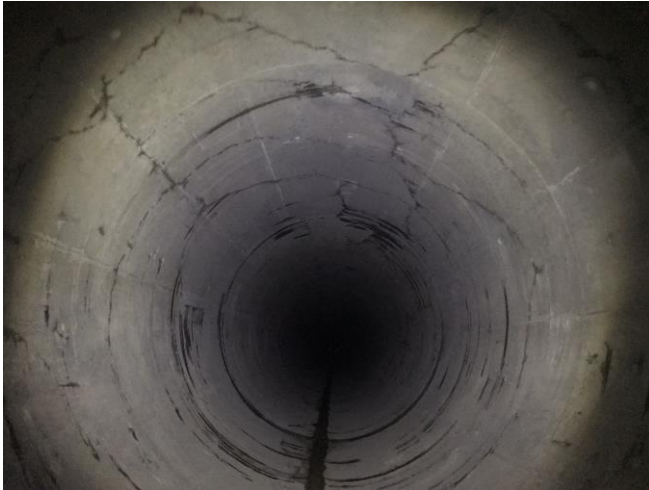
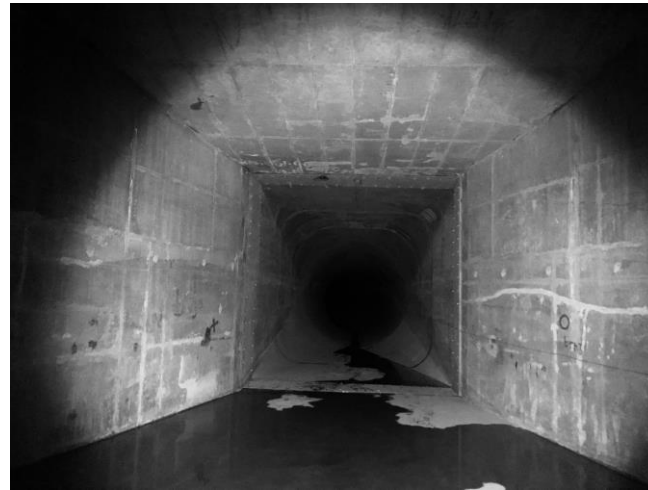
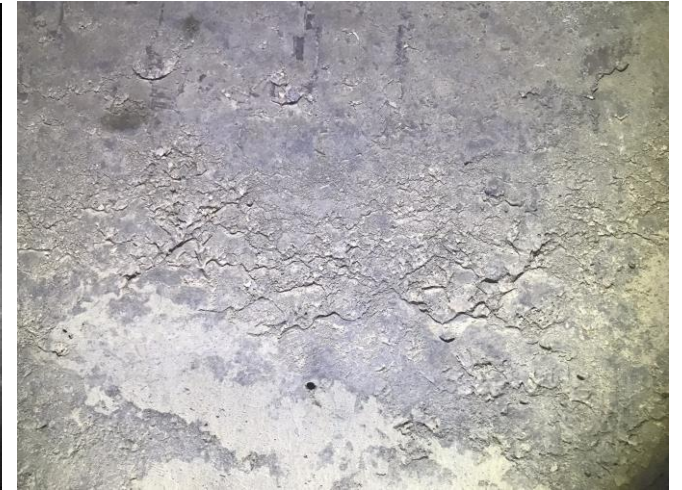
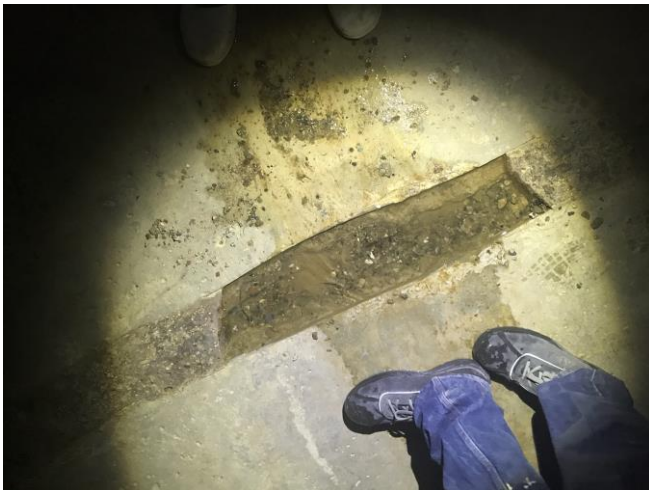
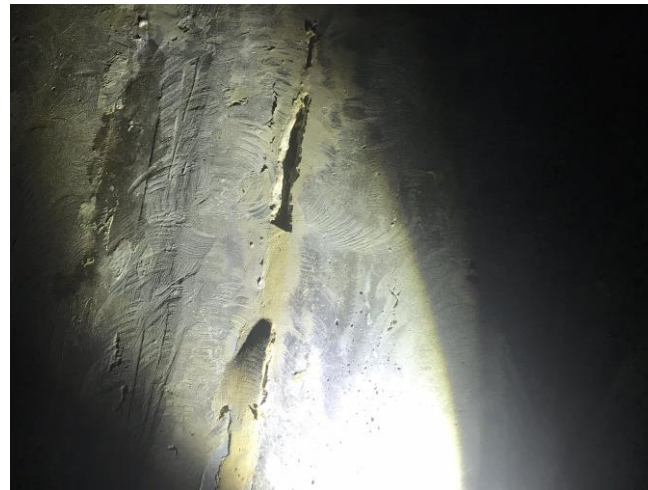
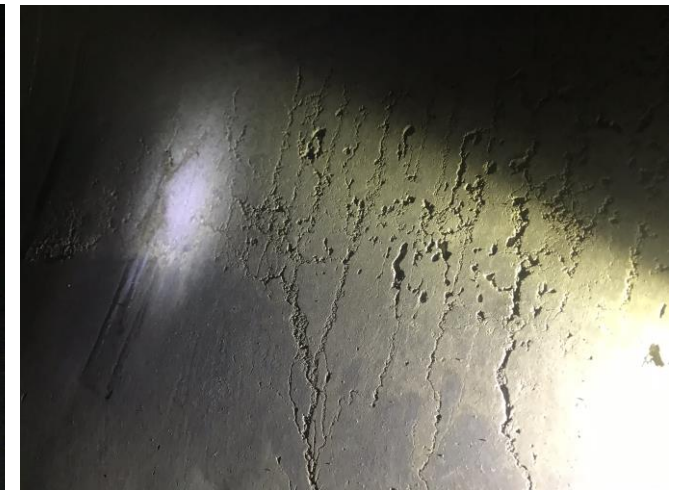
DETAILS

- Unfälle im Zuge der Ausbruch- bzw. Schutterungsarbeiten
- Massive Betonschäden und Undichtigkeiten im gesamten Hochdruckabschnitt
- Umfangreiche Betonschäden und Undichtigkeiten im gesamten Niederdruckabschnitt
- Massive Betonschäden und Undichtigkeiten im Schachtwasserschloss

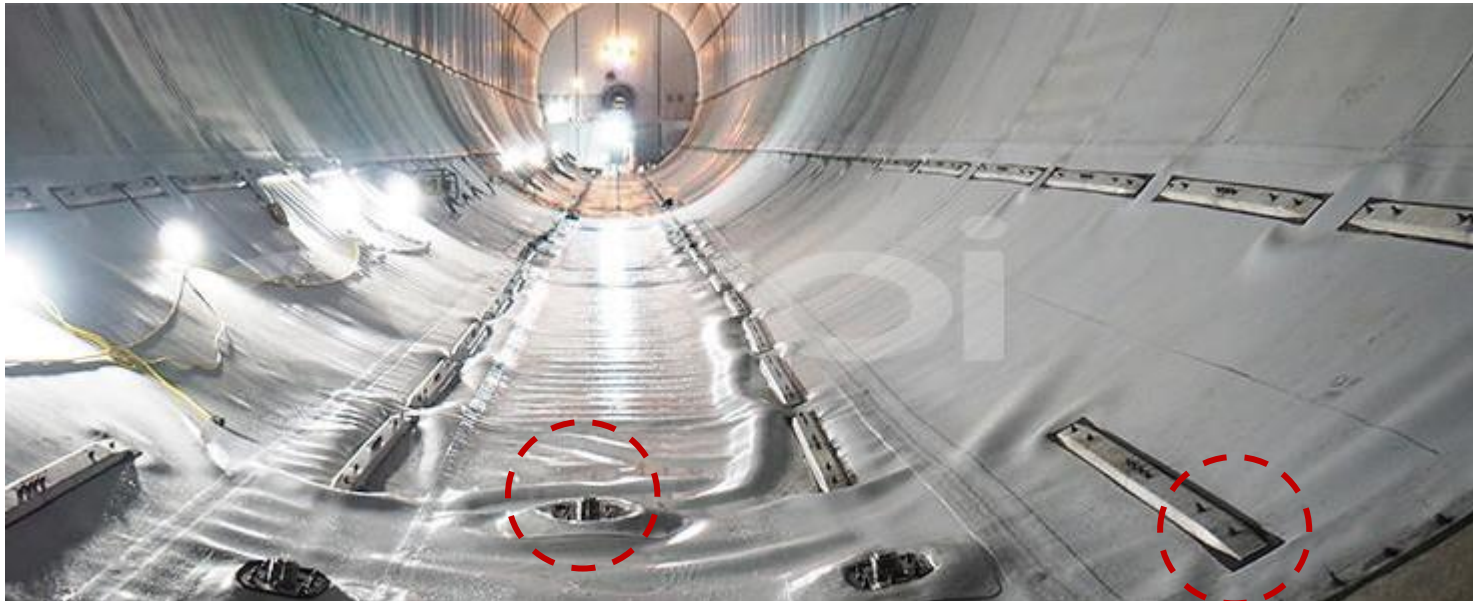
**EXTEND OF DEFECTS – HP SECTION**

- . **LEACKAGES AND STRUCTURAL DEFECTS ALONG THE COMPLETE HP SHAFT – 700m**
- . **LEACKAGES AND STRUCTURAL DEFECTS ALONG THE COMPLETE HP TUNNEL – 380m**
- . **CONSOLIDATION AND STRUCTURAL GROUTING NOT SUCCESSFULL**
- . GROUTING VOLUMES VERY LOW PRESSURES UP TO 12 BAR, NO TPA MONITORING
- . **THE COMPLETE HP PART WAS EQUIPPED WITH A SECONDARY PVC MAMBANE LINING**

**CLAMPING STRIPS + BOLTS**

- . **EXTERNAL WATER PRESSURE DURING DEWATERING**
- . **TEMP. DEPENDENT VARIATIONS**
- . **POT. DETACHMENT OF STRIPS AND MEMBRANE**

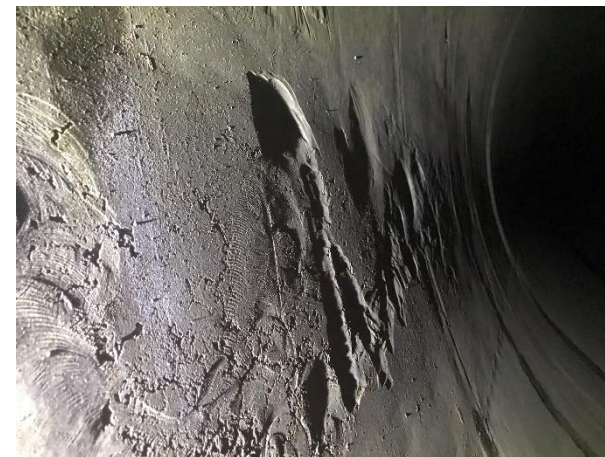
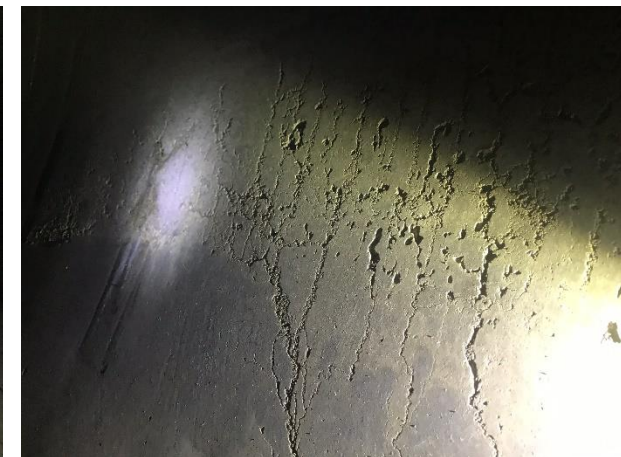
**EXTEND OF DEFECTS – LP SECTION**

- . LEACKAGES AND STRUCTURAL DEFECTS ALONG THE COMPLETE LP TUNNEL – 1300m**
- . 257 REPAIR PATCHES**
- . QUALITY CRITERIA NOT MET TO A GREAT EXTEND**
  - . REMOVAL OF DEFECT CONCRETE AND EXPOSURE OF REINFORCEMENT
  - . BONDING PRIMER ON REMAINING CONCRETE AND REBARSS
  - . IMPLEMENTATION OF HIGH PERFORMANCE MORTAR
- . POT. BONDING ISSUES**
- . EVENESS AND SURFACE QUALITY CRITERIA NOT MET**
- . HIDDEN DEFECTS NOT IDENTIFIED**

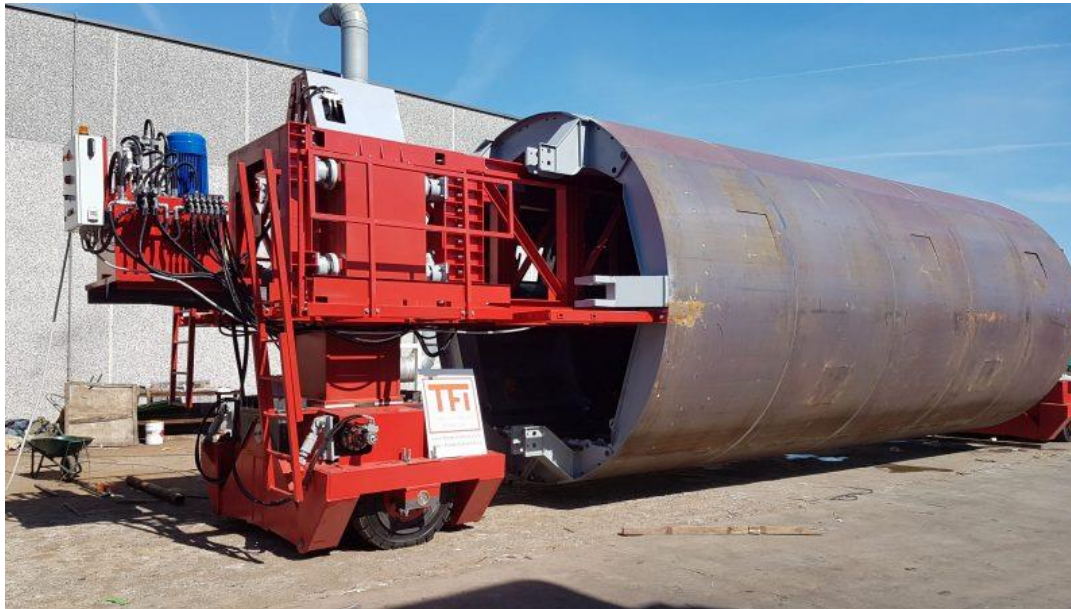
- . TRAVEL FORM WORK STABILITY ISSUES
- . INSUFFICIENT DIMENSIONING
- . LIMIT STATE INSTEAD OF ALLOWABLE DEFORMATION
- . RECURRING FAILURES
  - \_ CONCRETE OUTFLOW
  - \_ INTERRUPTION OF CONCRETE WORKS
  - \_ CONCRETE SUPPLY CHAIN DISTURBANCES
- . VIBRATING ACTUATORS ON FORMWORK FOR SCC !?

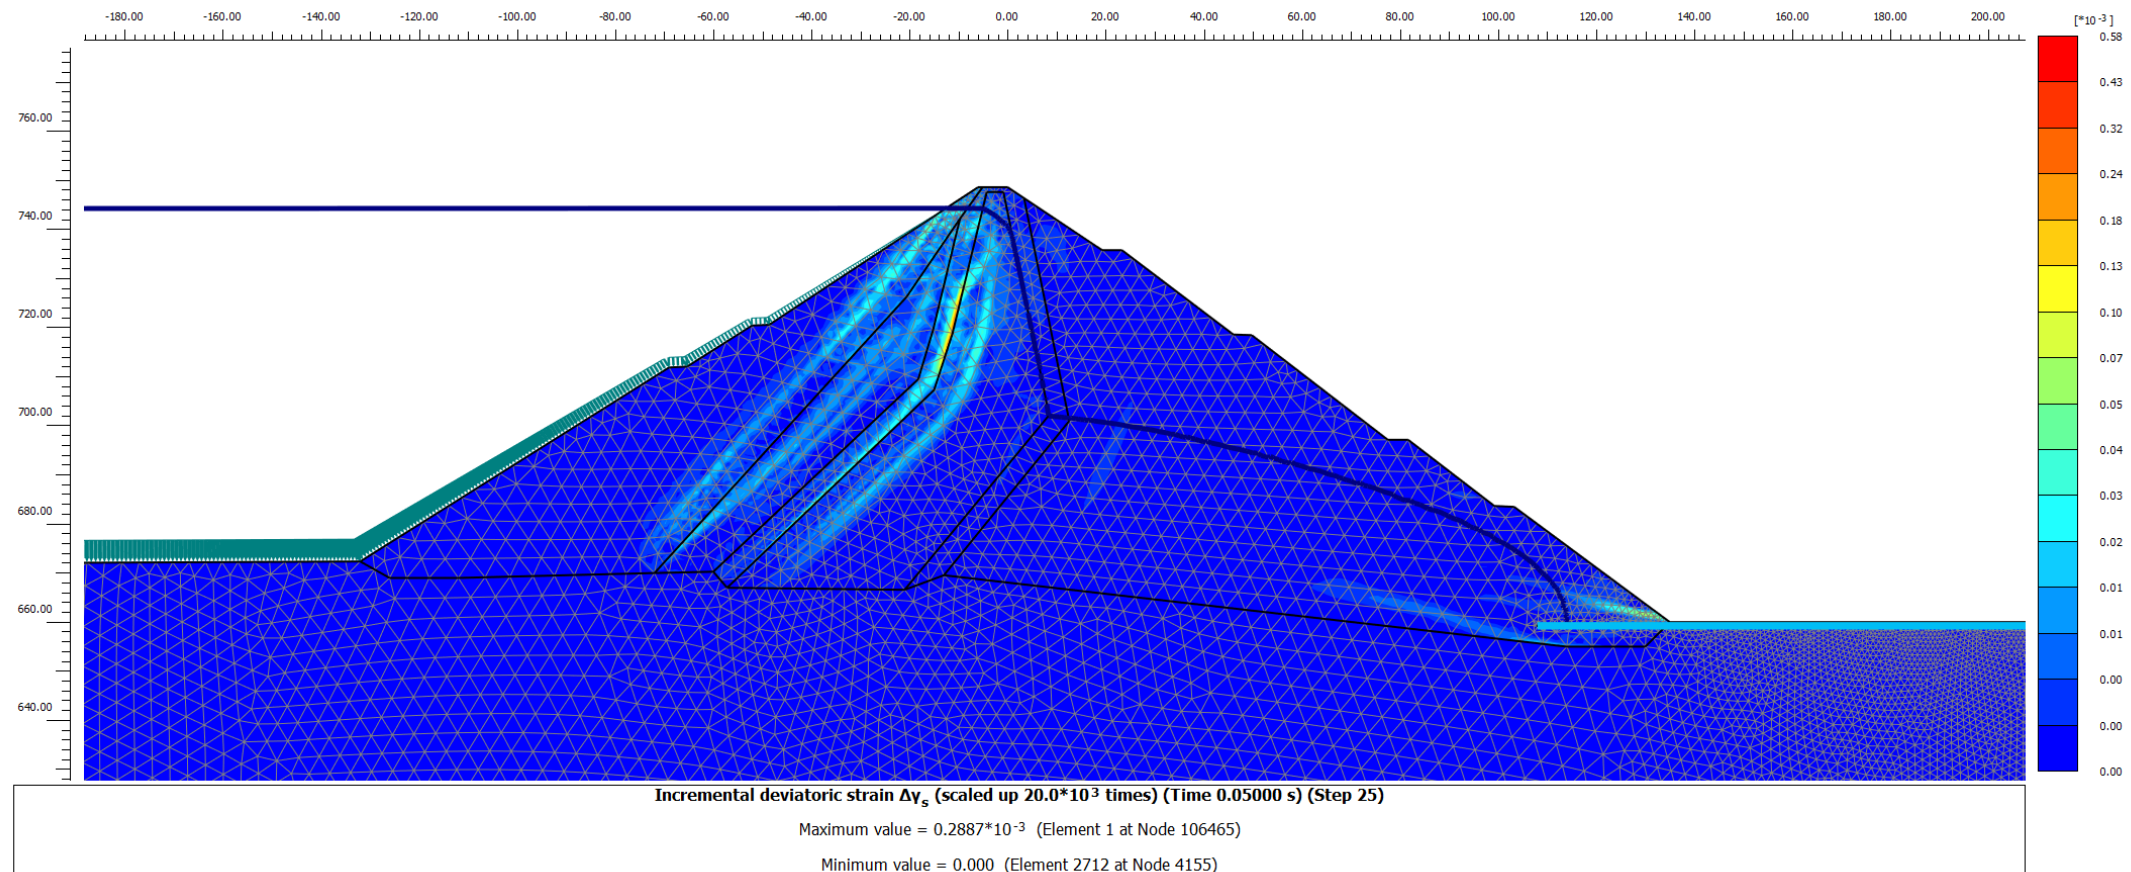
### FALL C - EBENE

### FE ANALYSE
